NASA TM X-1931

LOSS OF FORCED COOLING FLOW  
IN THE PLUM BROOK REACTOR

*by H. B. Barkley, Jr.*  
*Lewis Research Center*  
*Cleveland, Ohio*

NATIONAL AERONAUTICS AND SPACE ADMINISTRATION • WASHINGTON, D. C. • DECEMBER 1969

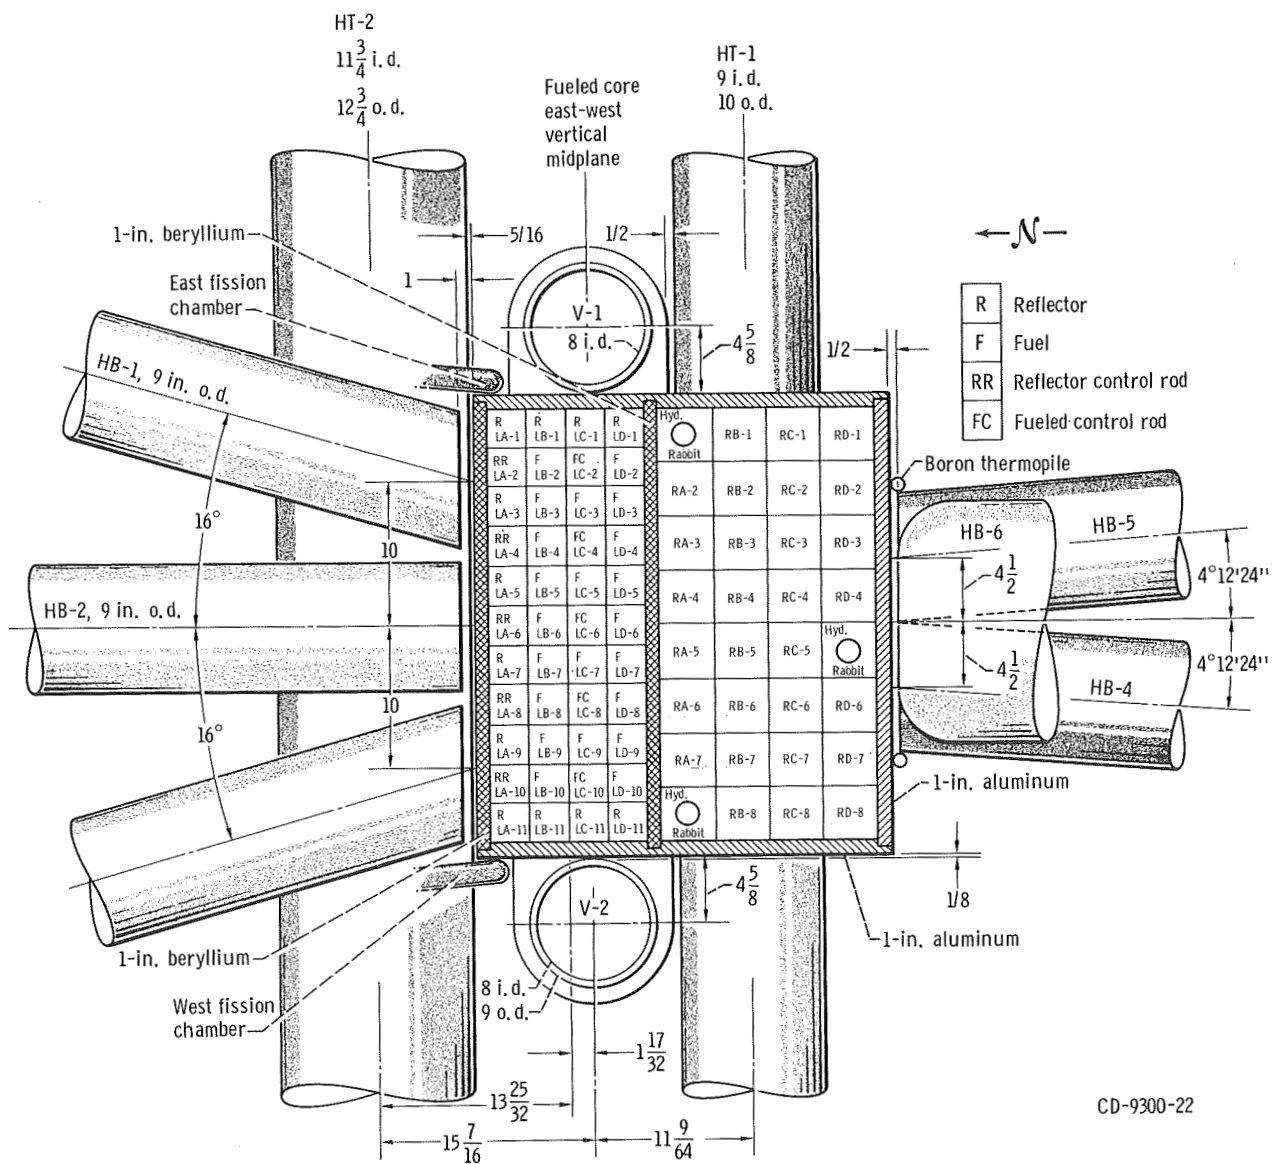
The Plum Brook Reactor (PBR) is a 60 megawatt (th) pressurized water test reactor. Figure 1 illustrates the layout of the reactor core and instrument and experiment facilities. Within the core box can be seen the 3x9 array of fuel elements, surrounded on three sides by a single row of beryllium "L-piece" reflectors, and on the fourth side by four rows of beryllium "R-piece" reflectors. Normal cooling water flow has two upward paths, through the R reflector and past the experiment facilities; and all water passes downward through the L reflector and fuel elements. The fuel elements are of the MTR curved plate type, with 20 mils of aluminum cladding on a uranium-aluminum alloy. At the hottest spot in the fuel the nominal heat flux is  $1.4 \times 10^6$  Btu per hour per square foot with a corresponding fuel element temperature of  $325^{\circ}$  F (less than saturation temperature). The steady-state departure from nucleate boiling ratio (DNBR) is greater than 2, and the transient DNBR is greater than 1.3.

Figure 1. - Horizontal section of reactor core. (Dimensions are in inches.)

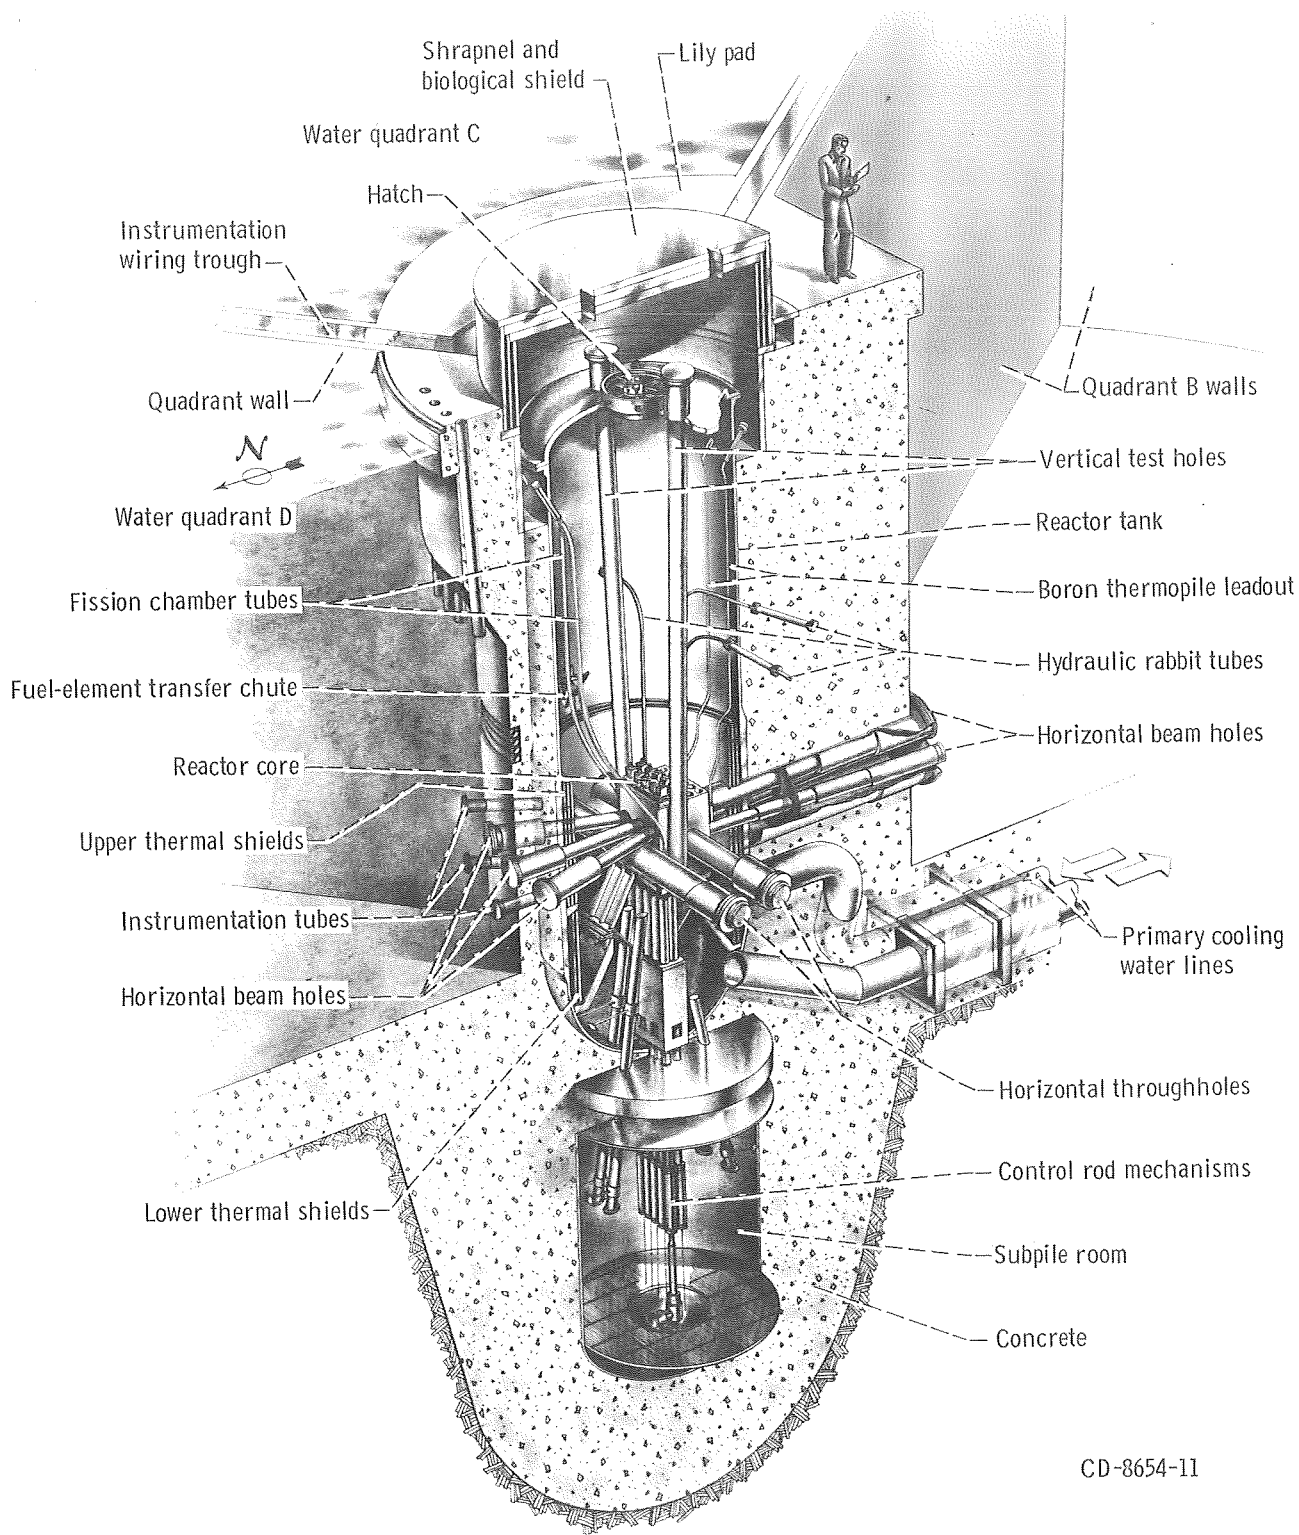
Figure 2 shows the reactor core located in the reactor tank. This provides a perspective view of the reactor, and the instrument and experiment facilities. The direction of normal flow can also be seen, upward past the experiment thimbles and through the R reflector, and downward through the L reflector and fuel elements.

Figure 2. - Reactor tank assembly.
